# Rompimento de Barragem em Brumadinho/MG - Brasil

## Chamado Charter 686

Imagem do Evento - 2019.01.26 - 19:20 - CSA/RADARSAT-2  
Imagem pré-evento - 2018.11.25 - CSA/RADARSAT-2  
Imagem base - 2018.10.23 - INPE/CBERS4

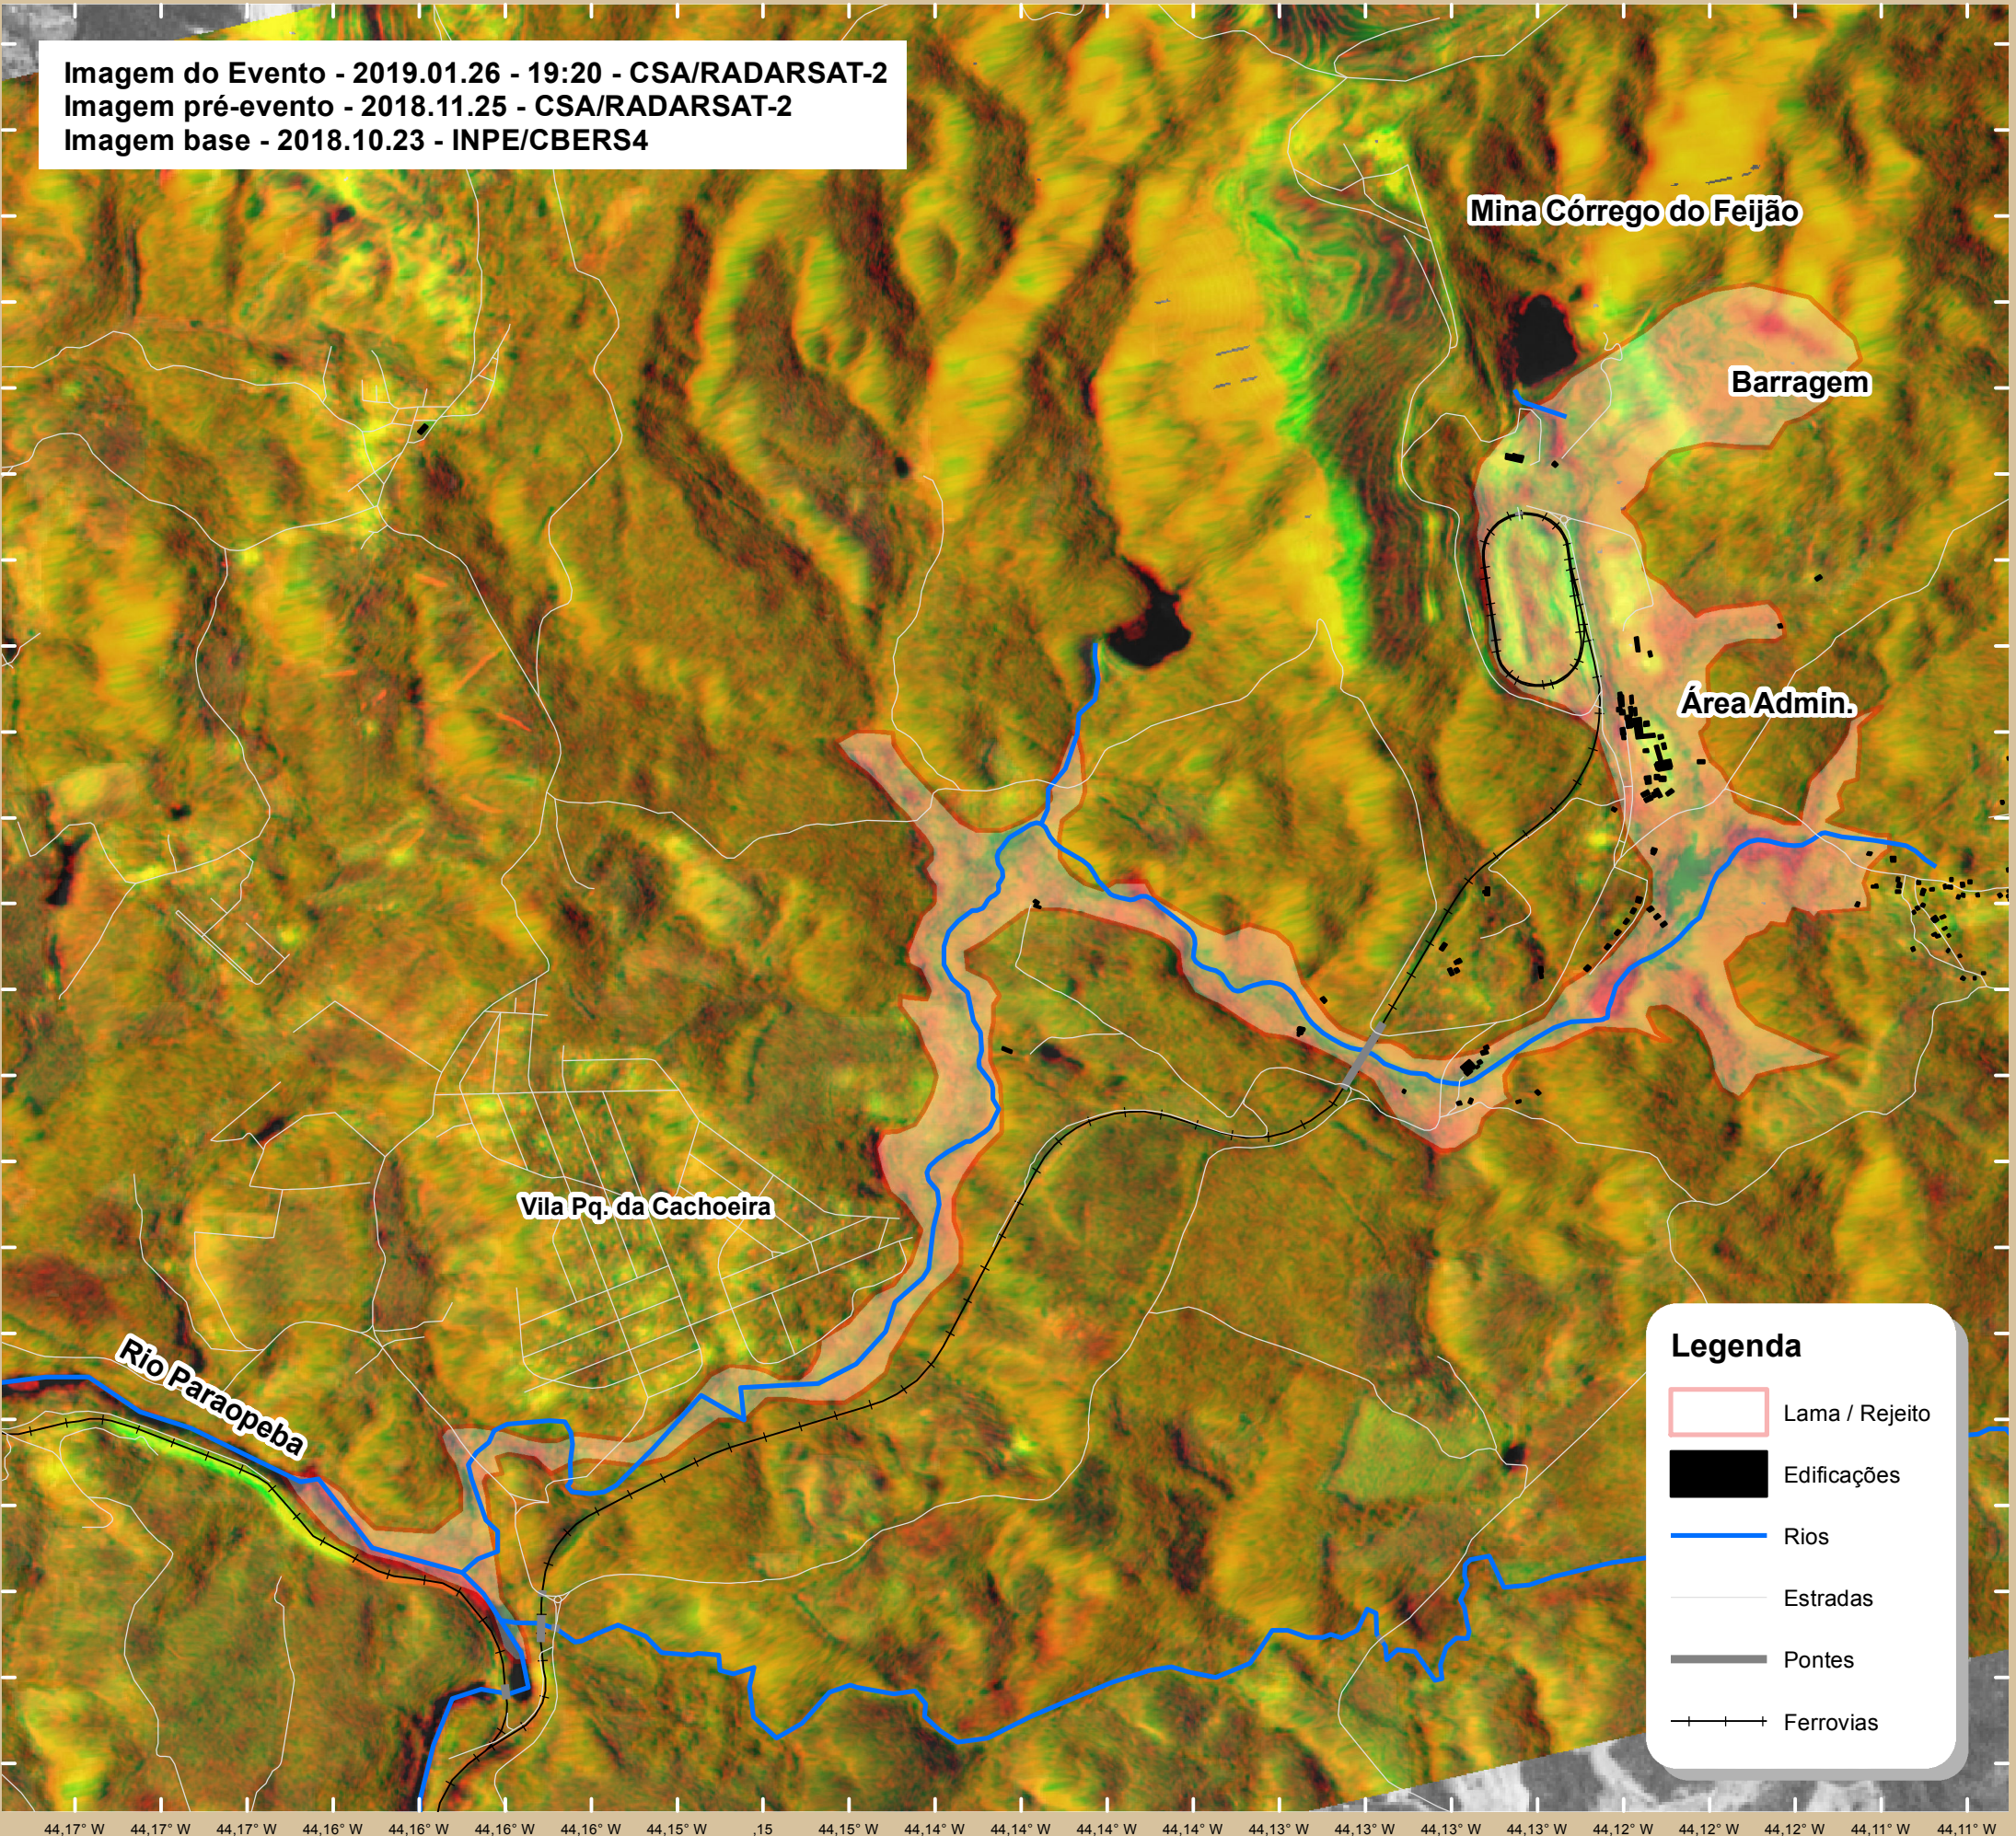
- Lama / Rejeito
- Edificações
- Rios
- Estradas
- Pontes
- Ferrovias

Evento:  
CSA / RADARSAT-2  
Instrumento: SAR\_RAD\_2  
Obtida em 2019.01.26  
Modo: Ultrafine, U71 - Polarization HH

Pré-Evento:  
CSA / RADARSAT-2  
Instrumento: SAR\_RAD\_2  
Obtida em 2018.11.25  
Modo: Multi-Look Fine, MF21 - Polarization HH

Imagem Base:  
INPE / CBERS-4  
Instrument: panMUX - Resolution 10m  
Acquired on 2018.10.23
